INTERSTATE COMMERCE COMMISSION

REPORT OF ACCIDENT ON
THE NEW ORLEANS & NORTHEASTERN
RAILROAD NEAR EASTABUCHIE,
MISS , MAY 6, 1912

BY THE CHIEF INSPECTOR OF
SAFETY APPLIANCES

REPORT OF THE CHIEF INSPECTOR OF SAFETY
APPLIANCES COVERING HIS INVESTIGATION
OF AN ACCIDENT WHICH OCCURRED ON THE
NEW ORLEANS & NORTHEASTERN RAILROAD
NEAR EASTABUCHIE, MISS. MAY 6, 1912.

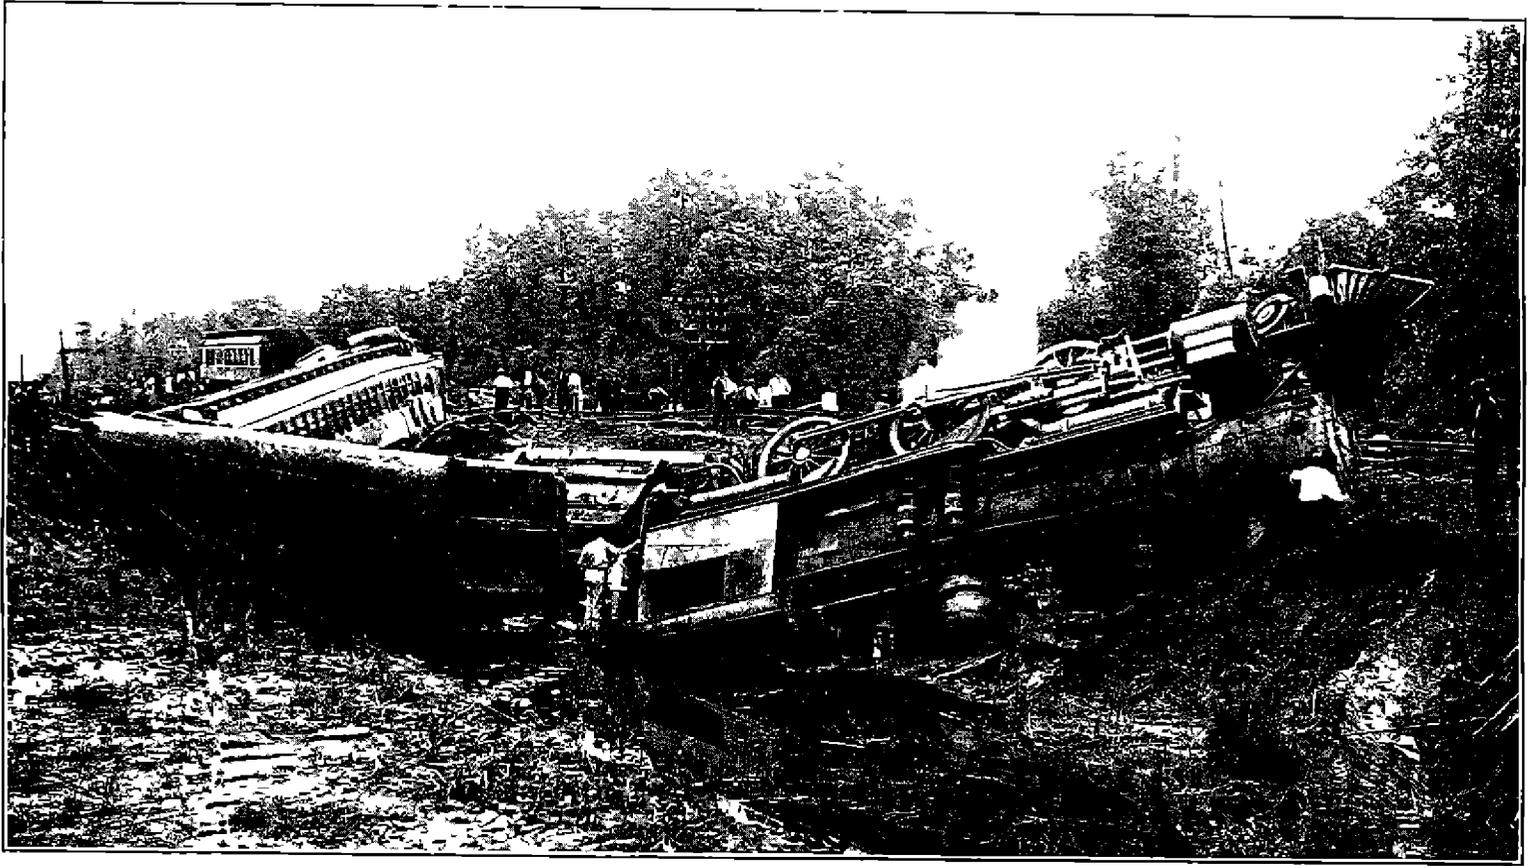
As will be seen by reference to illustration No 1 the engine and tender passed over the trestle before turning over, at a point about 180 feet north of the same. The combination baggage and passenger car turned over on its side. The second and third cars remained practically upright. No passengers were killed in any of the first three cars. The next two cars tourist sleeping cars Nos 1302 and 1161, crushed through the trestle and telescoped each other being practically destroyed. It was in these two cars that the six passengers were killed. The sixth car in the train the dining car had the forward set of trucks derailed, but escaped other damage as did the remaining five cars in the train, all of which remained on the rails.

The first three cars of this train were of steel underframe construction and none of them was materially damaged as is shown by illustration No. 1. In illustration No. 2 the dining car is seen at the left standing on the southern end of the trestle. On the right is seen the third car of the train, the body of it being practically undam-

1 GENERAL VIEW OF DERAILMENT LOOKING SOUTH

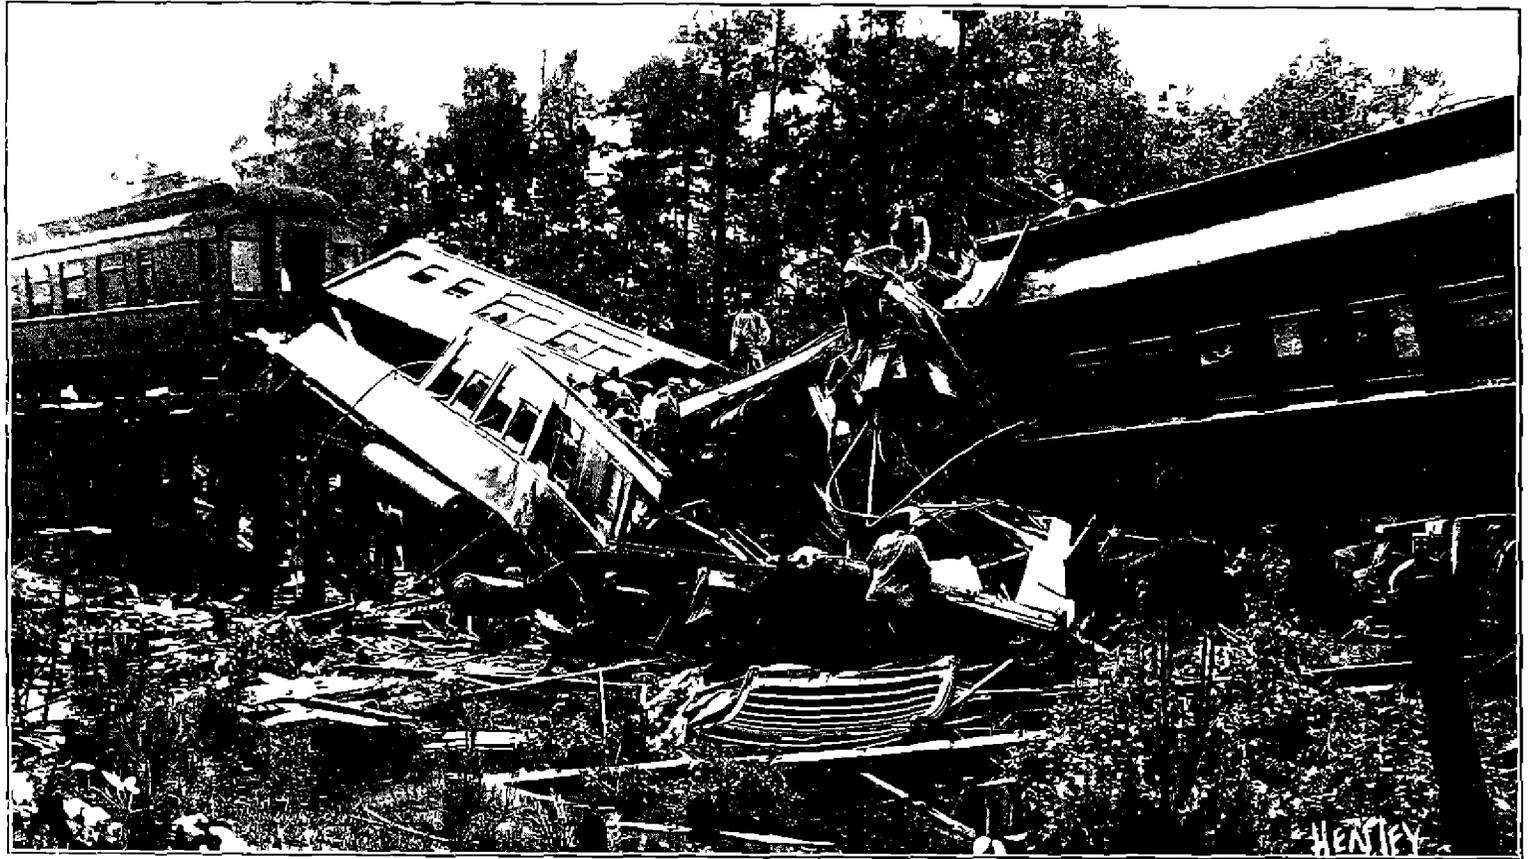
aged. Between these two cars can be seen the remnants of the two wooden tourist cars, one of which was built 26 years ago, the other 32 years ago. What happened to these two cars can not but lend emphasis to the recommendation contained in the Commission's last report to Congress that the adoption of steel cars be required. The bridge through which these cars plunged although in good condition and well maintained was not of sufficient strength to withstand the pressure to which it was subjected. Had these cars been of modern steel underframe or all-steel construction, or had the bridge been of stronger construction, the long list of casualties would undoubtedly have been greatly reduced.

2 VIEW SHOWING FRAGMENTS OF TOURIST SLEEPING CARS NOS 1102 AND 1161
